**EXAMINATION OF THE PRESSURE TUBE
RUPTURE AT PICKERING NGS 'A'
UNIT 2, FUEL CHANNEL G16**

-- TECHNICAL REPORT --

Report No. 84-08-09-1

Date: March 1984

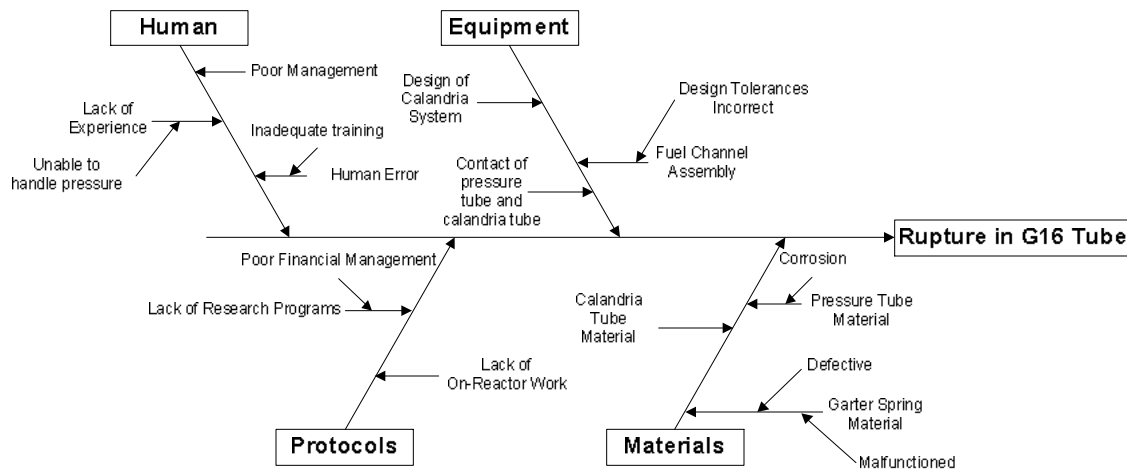
Fig 1: Cause and Effect Diagram shows all the possible causes for the rupture in pressure tube G16.
