**EXAMINATION OF THE PRESSURE TUBE
RUPTURE AT PICKERING NGS 'A'
UNIT 2, FUEL CHANNEL G16**

-- TECHNICAL REPORT --

Report No. 84-08-09-1

Date: March 1984

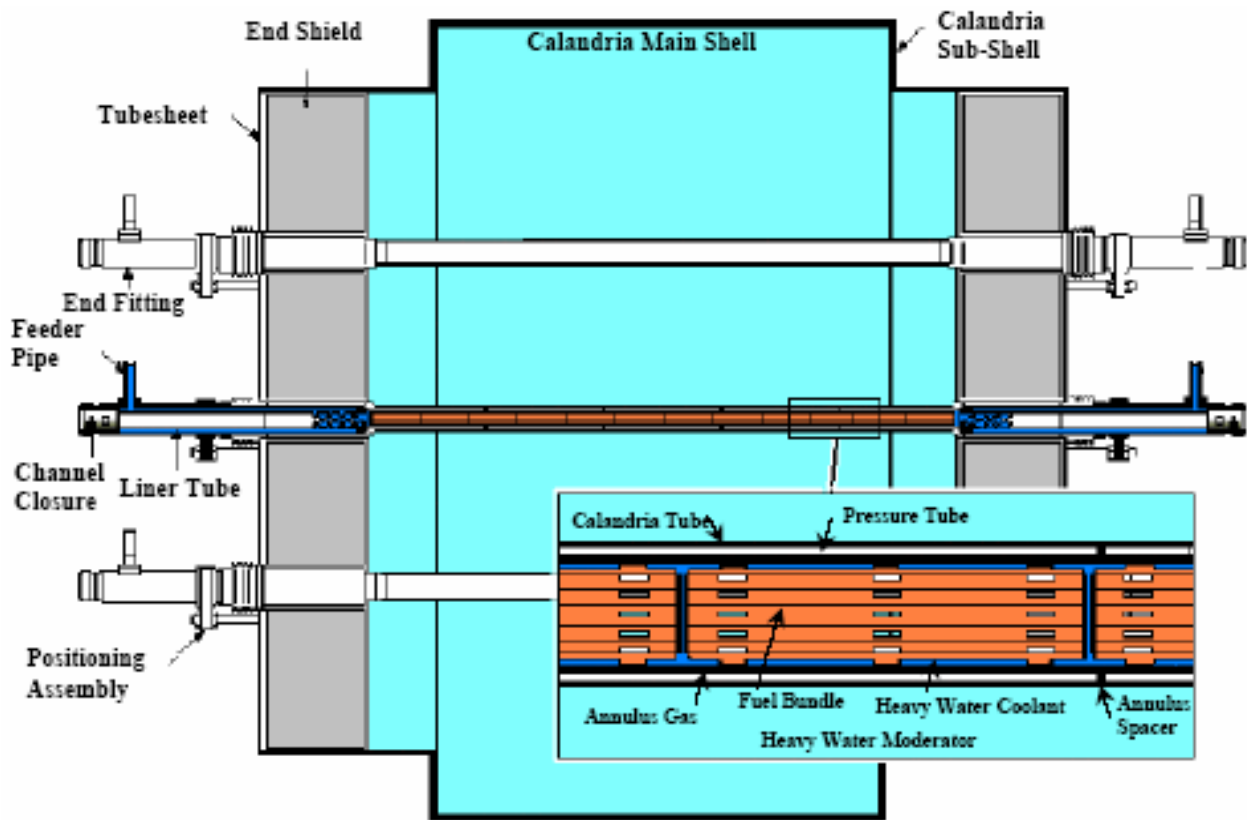
The CANDU (Canada Deuterium Uranium) reactor consists of a horizontally mounted vessel approximately 6 meters in diameter termed the calandria, sealed at each end by plates called end shields. Inside the Pickering NGS Unit A reactor, 390 fuel channels manufactured from a Zirconium-Niobium alloy 4.3mm thick and 104 mm in diameter, span the entire length of the calandria. As shown in the figure below, the pressure tubes are inserted into slightly larger calandria tube, with Garter Spring (annulus) spacers separating the two tubes every 1.5 to 2 meters.

Figure 3. The diagram above shows only 3 fuel channels. The CANDU reactor at Pickering NGS contains 390 of these tubes.

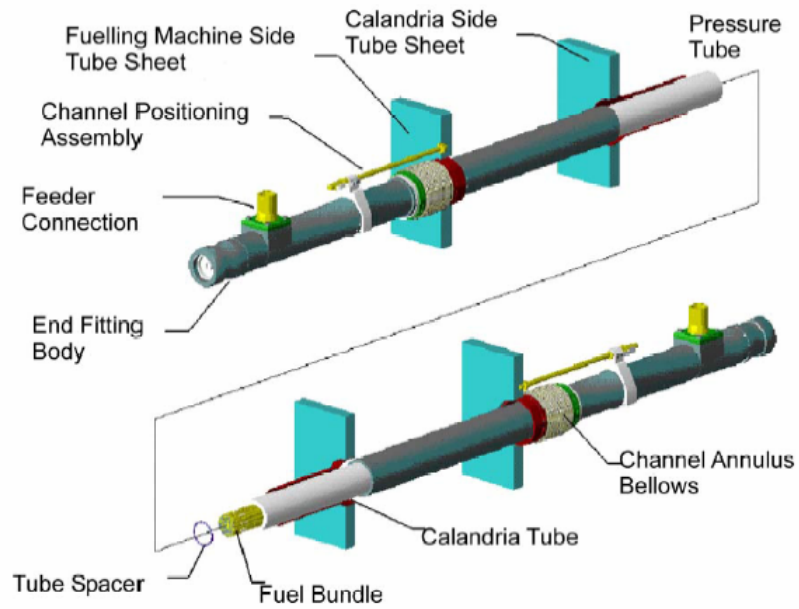
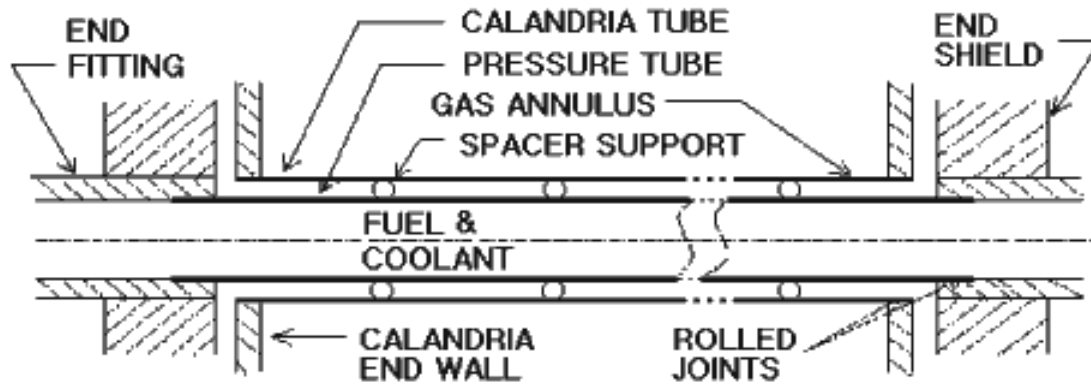
FUEL CHANNEL FEATURES

8. *Radiaion Creep and Sag*: Due to permanent volumetric expansion, the pressure tube and calandria tube come into contact
9. Garter springs (annulus spacers) are found in a location that is not their original design location, resulting in contact between pressure and calandria tubes.

<p><i>Radiation Creep and Sag:</i></p>	<p>Due to permanent volumetric expansion, the pressure tube and calandria tube come into contact</p>	<p>Inspect calandria tube and pressure tube regularly for creep and sag</p>	<p>Install proximity sensors between calandria tube and pressure tube to monitor their distances</p>
